Manhole Inspection Summary

Manhole # S550__035MH

Location Address: **rear 1130 s highland av**

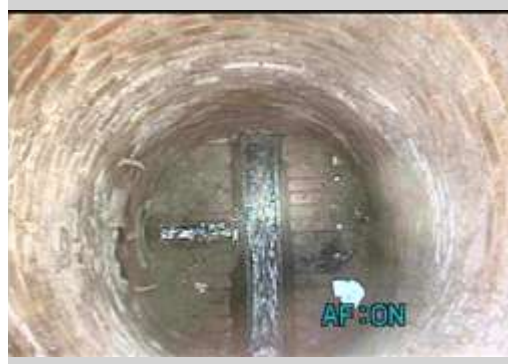
Top View

Condition: ☐ Sound ☐ Cracked ☐ Root Intrusion ☒ Loose Brick ☒ Deteriorated

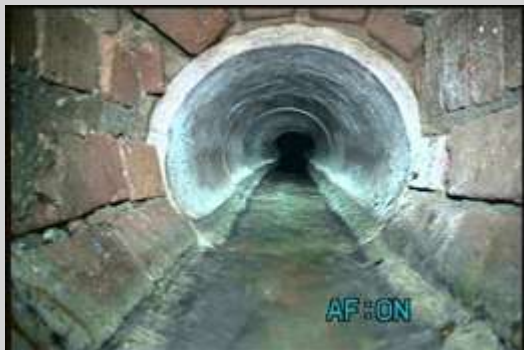
12 O'Clock Outflow

10 in. Circular Gravity Sewer
Pipe Out @ 12 O'Clock

Pipe Material: **Clay** ☐ Pipe Lined

Deposits: ☒ None ☐ Mud ☐ Sludge ☐ Debris ☐ Grease

Infiltration: **None** Pipe Seal Cond: **Unknown**

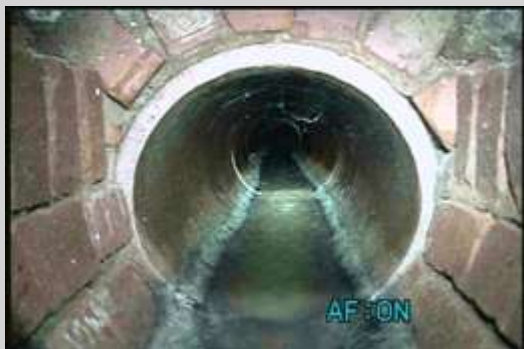
6 O'Clock Inflow

10 in. Circular Gravity Sewer
Pipe In @ 6 O'Clock

Pipe Material: **Clay** ☐ Pipe Lined

Infiltration: **None** Pipe Seal Cond: **Unknown**
